HISTORIC STRUCTURE REPORT

SHIRLEY-EUSTIS HOUSE

Roxbury, Massachusetts

1979

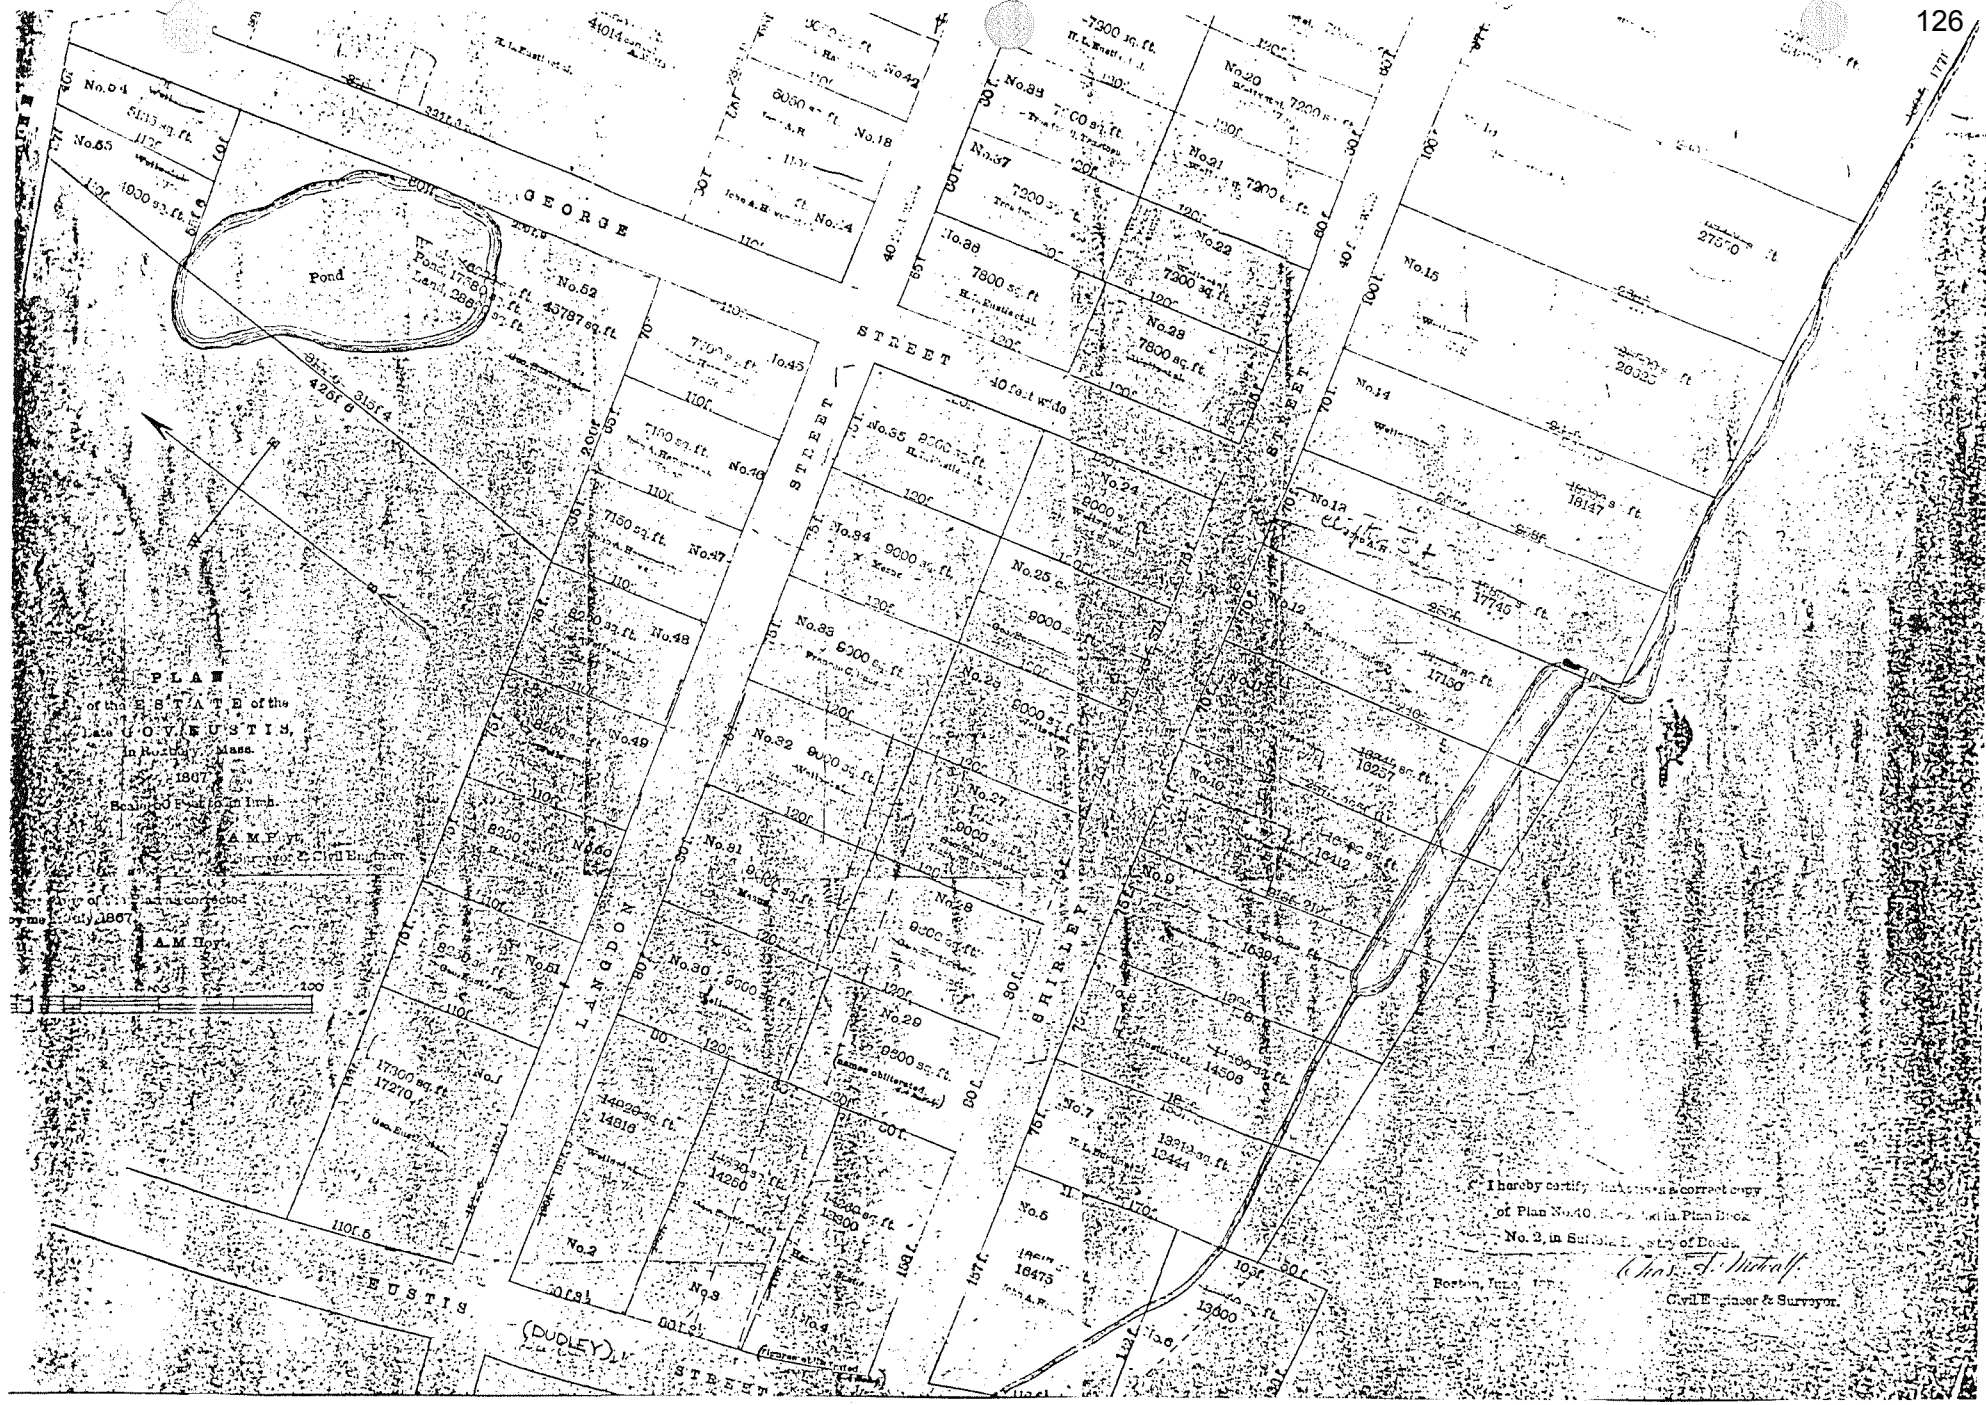
Fig. A-6. "Plan of the Estate of the Late Gov. Eustis in Roxbury, Mass., 1867", showing ponds and subdivision into Lots. (Suffolk Co. Plan Book 2, Plate 40, Registry of Deeds)

- Fig. A-6. "Plan of the Estate of the Late Gov. Eustis in Roxbury, Mass., 1867", showing ponds and subdivision into Lots. (Suffolk Co. Plan Book 2, Plate 40, Registry of Deeds)

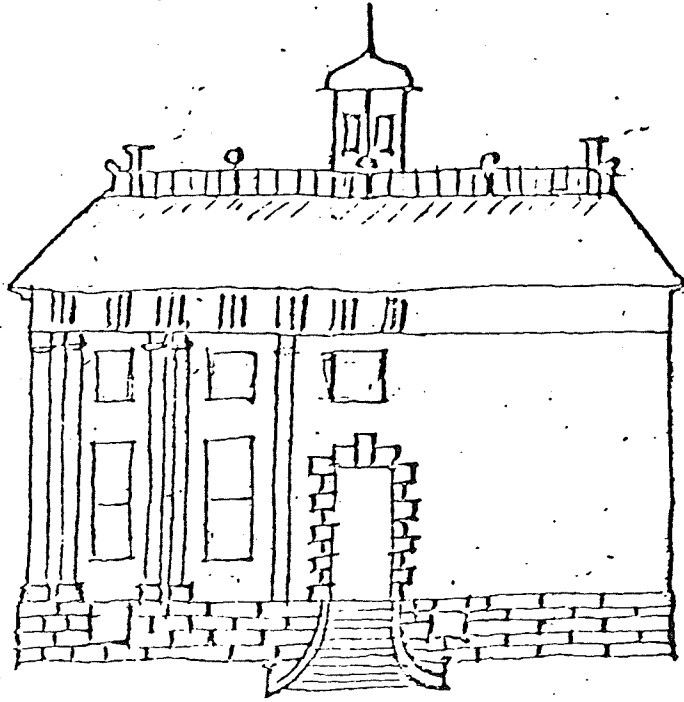
Front aspect, with double Doric Pilasters

Fig. B-1. "Gov. Shirley's Seat at Dorchester", now Roxbury, Boston. Rev. Ezra Stile's sketch, c. 1763. (Beinicke Library, Yale University)

On the exterior, indirect evidence was found to corroborate Stiles's view (Fig. B-1) and Benjamin Eustis's account of the pilasters and Doric entablature. The pilasters survive, however, in altered form and a photo showing a seam over which the Federal neck molding was installed attests to the probable removal of wide Doric frieze, and extension of the pilaster. Shadows of the former Georgian capital in the paint below the existing Federal capitals are evidence the later capitals were raised (Fig. C-9). Evidence for the former existence of smaller second floor windows, shown in Stiles's view, is obvious in that the original interior trim and openings were left intact during the Federal remodelling, and the larger new sash simply extended past on the exterior (Fig. E-21).

The original west front of the foundation and stone steps at the entrance are visible in the 1867 photo (Fig. C-2), which also seems to corroborate Stiles's 1763 view (Fig. B-1). The photo shows roughly square basement openings centered under each window bay of the house with eight over eight sash. These would

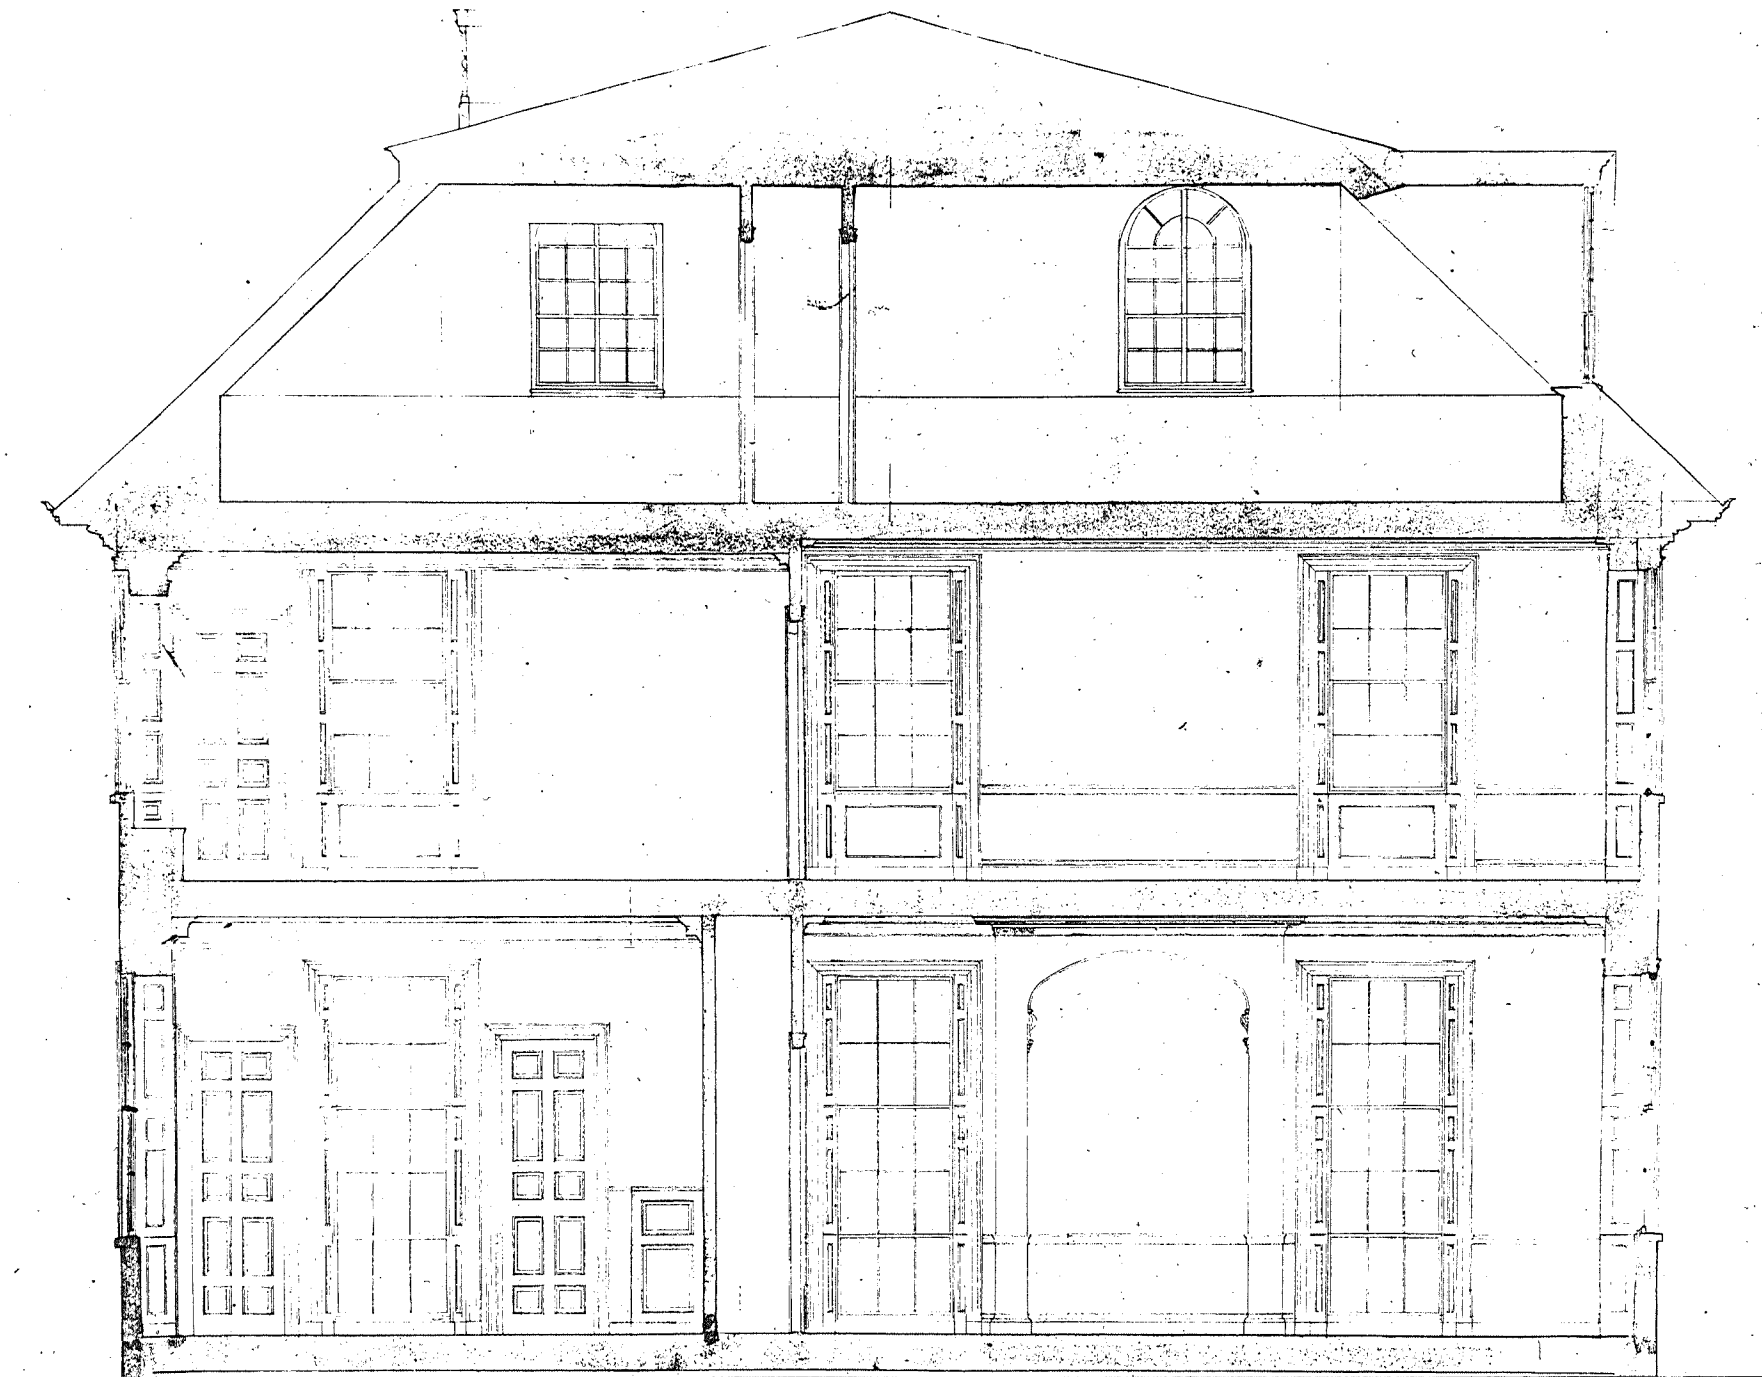
Fig. B-13. Section Looking North, ca. 1890, by Ogden Codman, Jr. Architect, showing Dining Room sideboard alcove and decorative plaster work. (Codman Collection of Architectural Drawings, SPNEA)

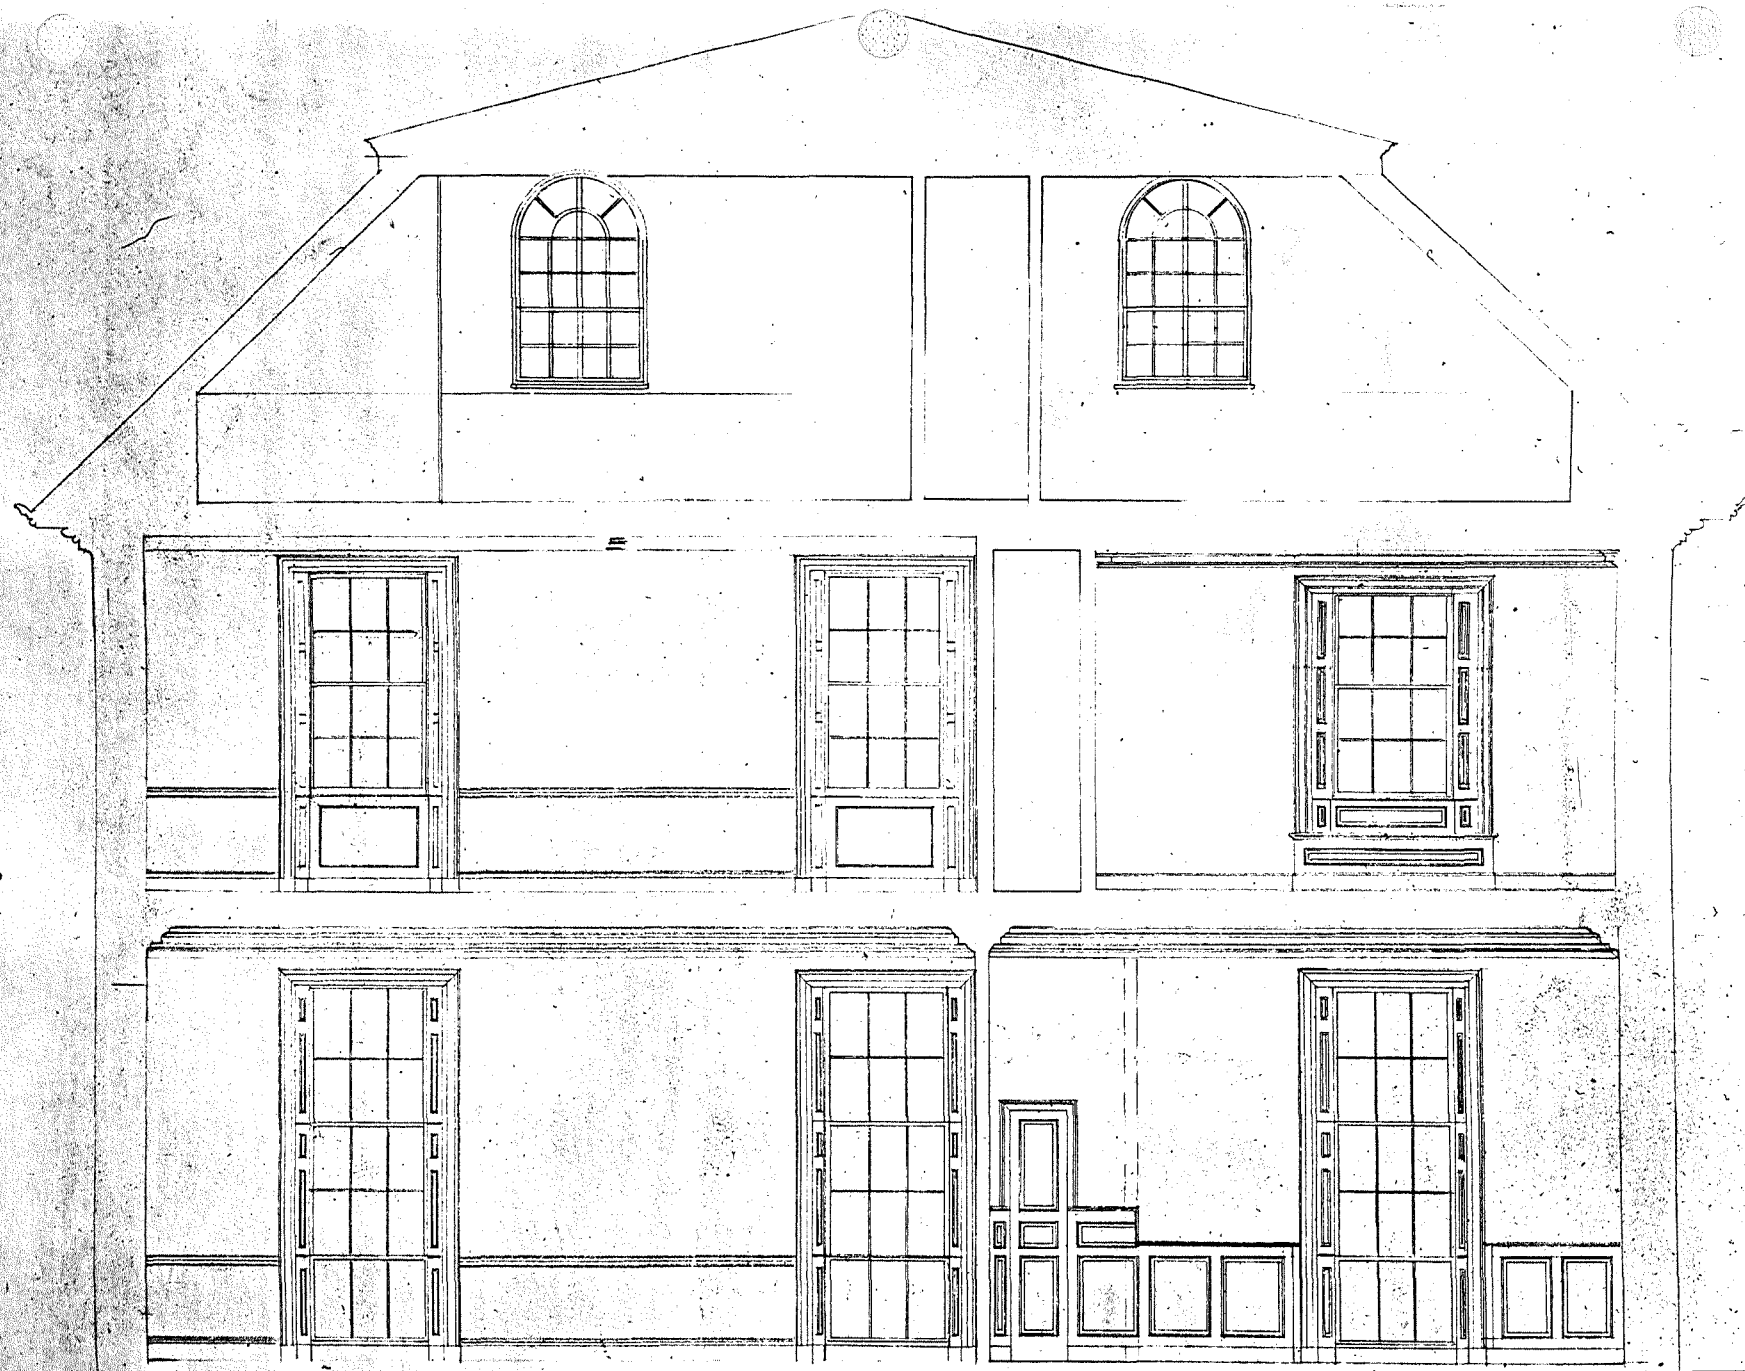
Fig. B-14. Section Looking South, ca. 1890, by Ogden Codman, Jr. Architect, showing original and cut down dado of Breakfast Room. (Codman Collection of Architectural Drawings, SPNEA)

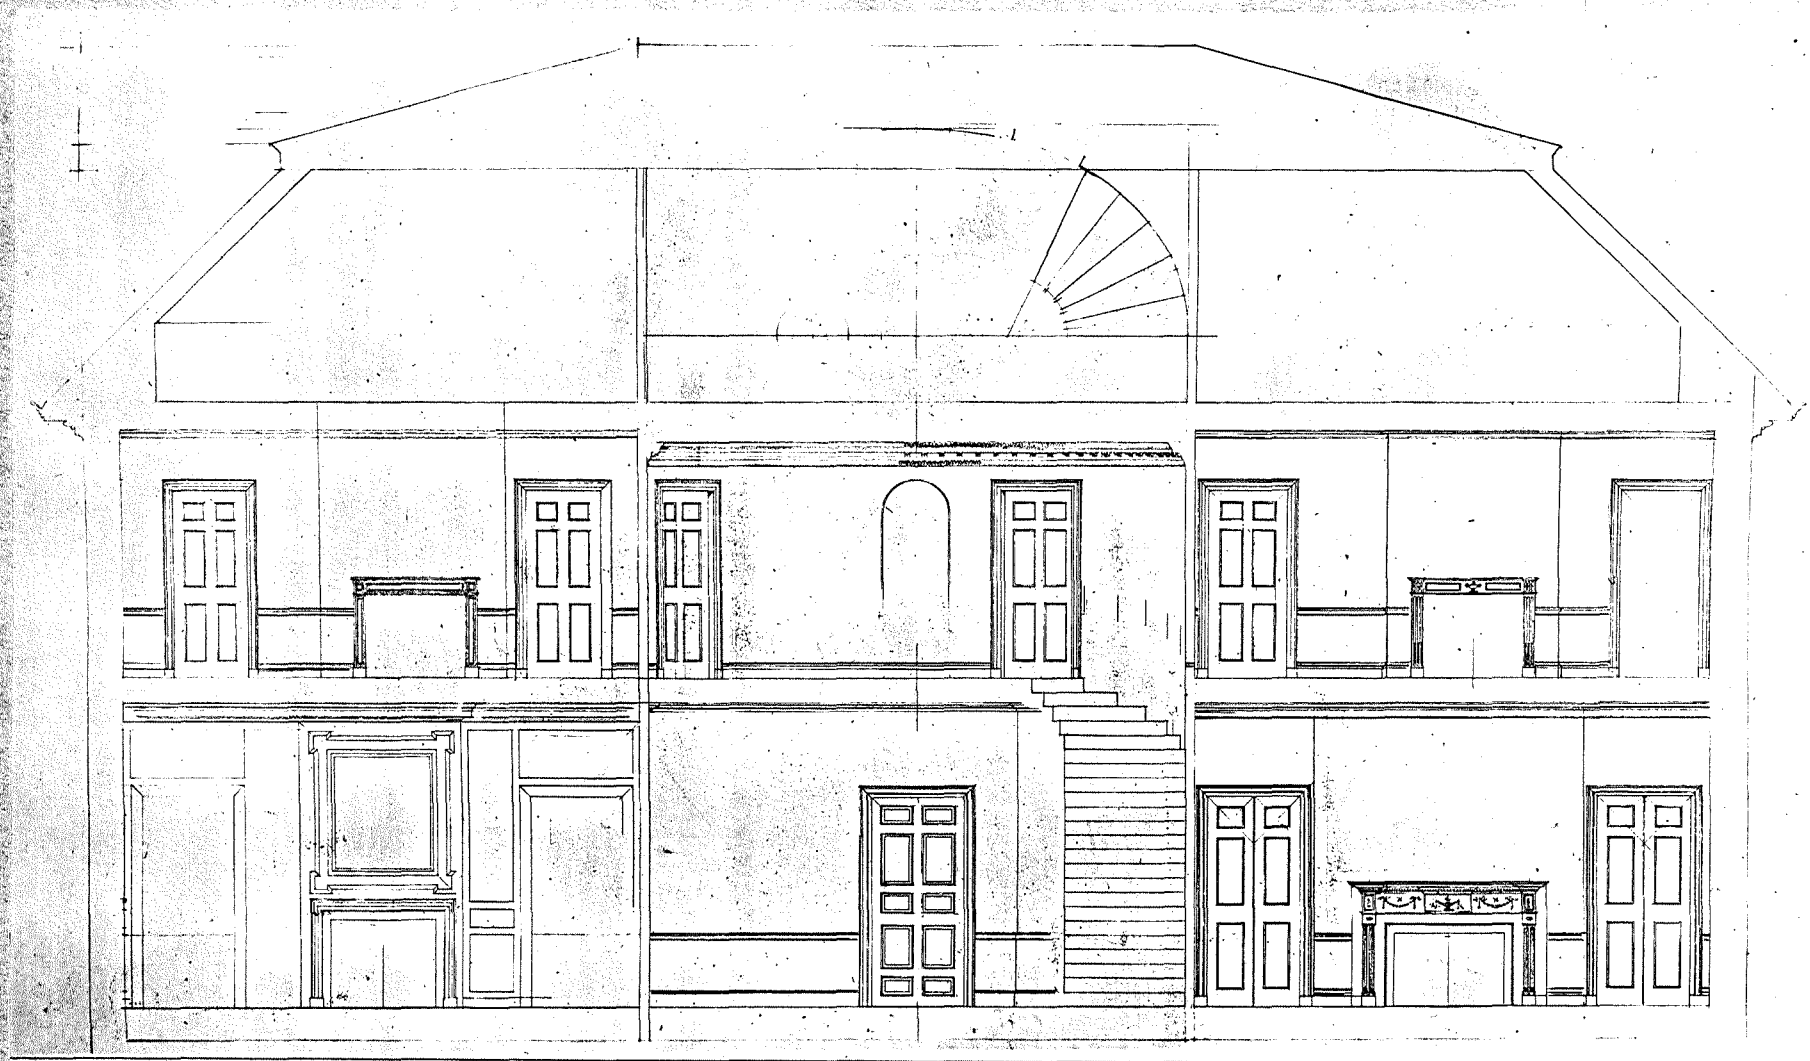
Fig. B-15. Chimney Wall Section Looking West, ca. 1890, by Ogden Codman, Jr., Architect, showing original mantels on second floor; first floor overmantel panel and mantel restored on paper. (Codman Collection of Architectural Drawings, SPNEA)

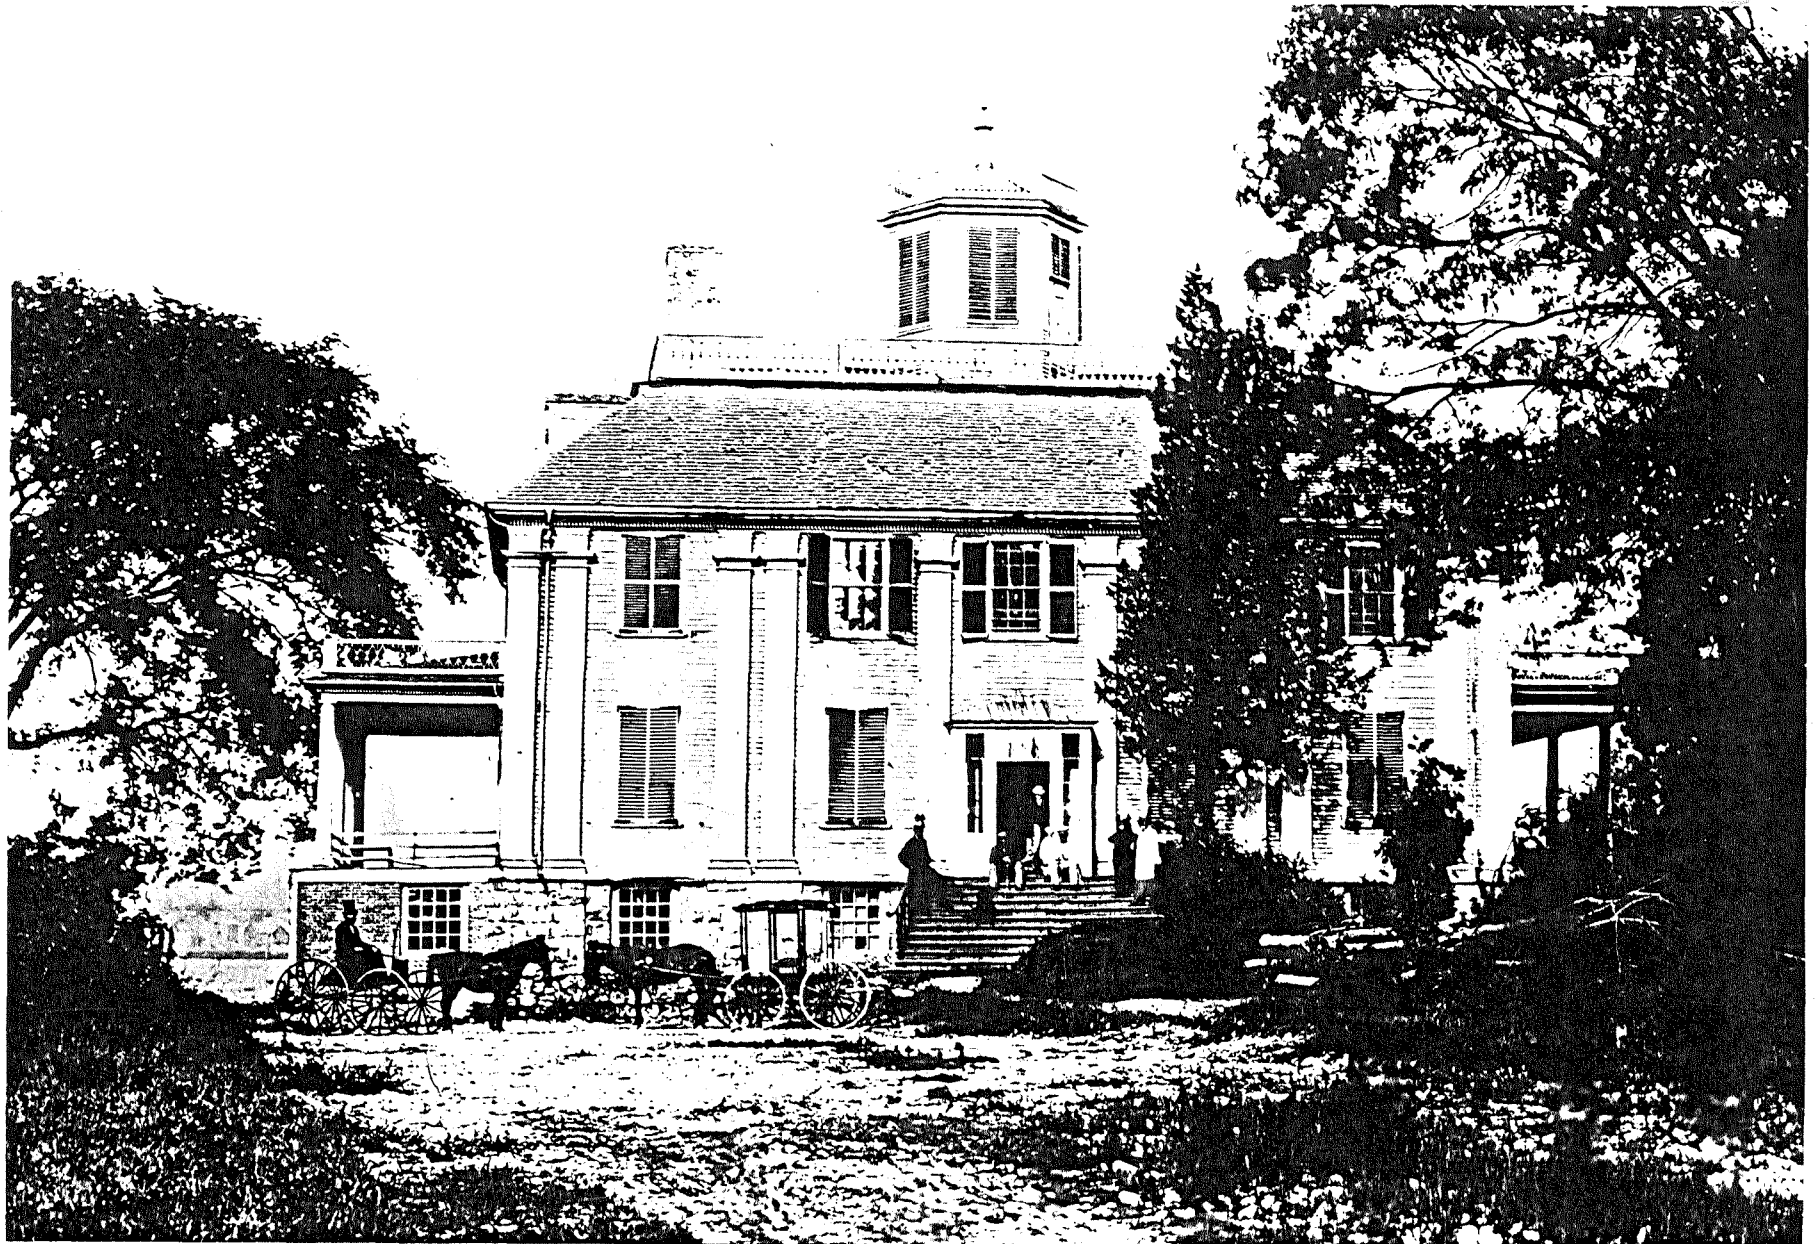
Fig. C-2. Detail of Shirley-Eustis House, Roxbury, Mass.", showing re-grading at house, original basement windows and front steps. Copy by Baldwin Coolidge. (SPNEA Copy Neg. 1124-B).

The original front steps shown in the 1867 view (Fig. C-2), extend to the outer edge of the pilasters of the center bay at the house, and gradually widen to reach the edges of the basement windows at ground level. As shown in the Stiles view, they had, in 1867, a curved splay and a wrought iron railing with apparent ball finials. A molded nosing is visible on the steps in the photo as seen under magnification. Apparent remnants of these brownstone steps were found at the entrance to 42-44 Shirley Street, traditionally part of the former barn converted to a double house (Fig. E-4). Evidence about the former appearance of the west facade is summarized in Fig. D-2.

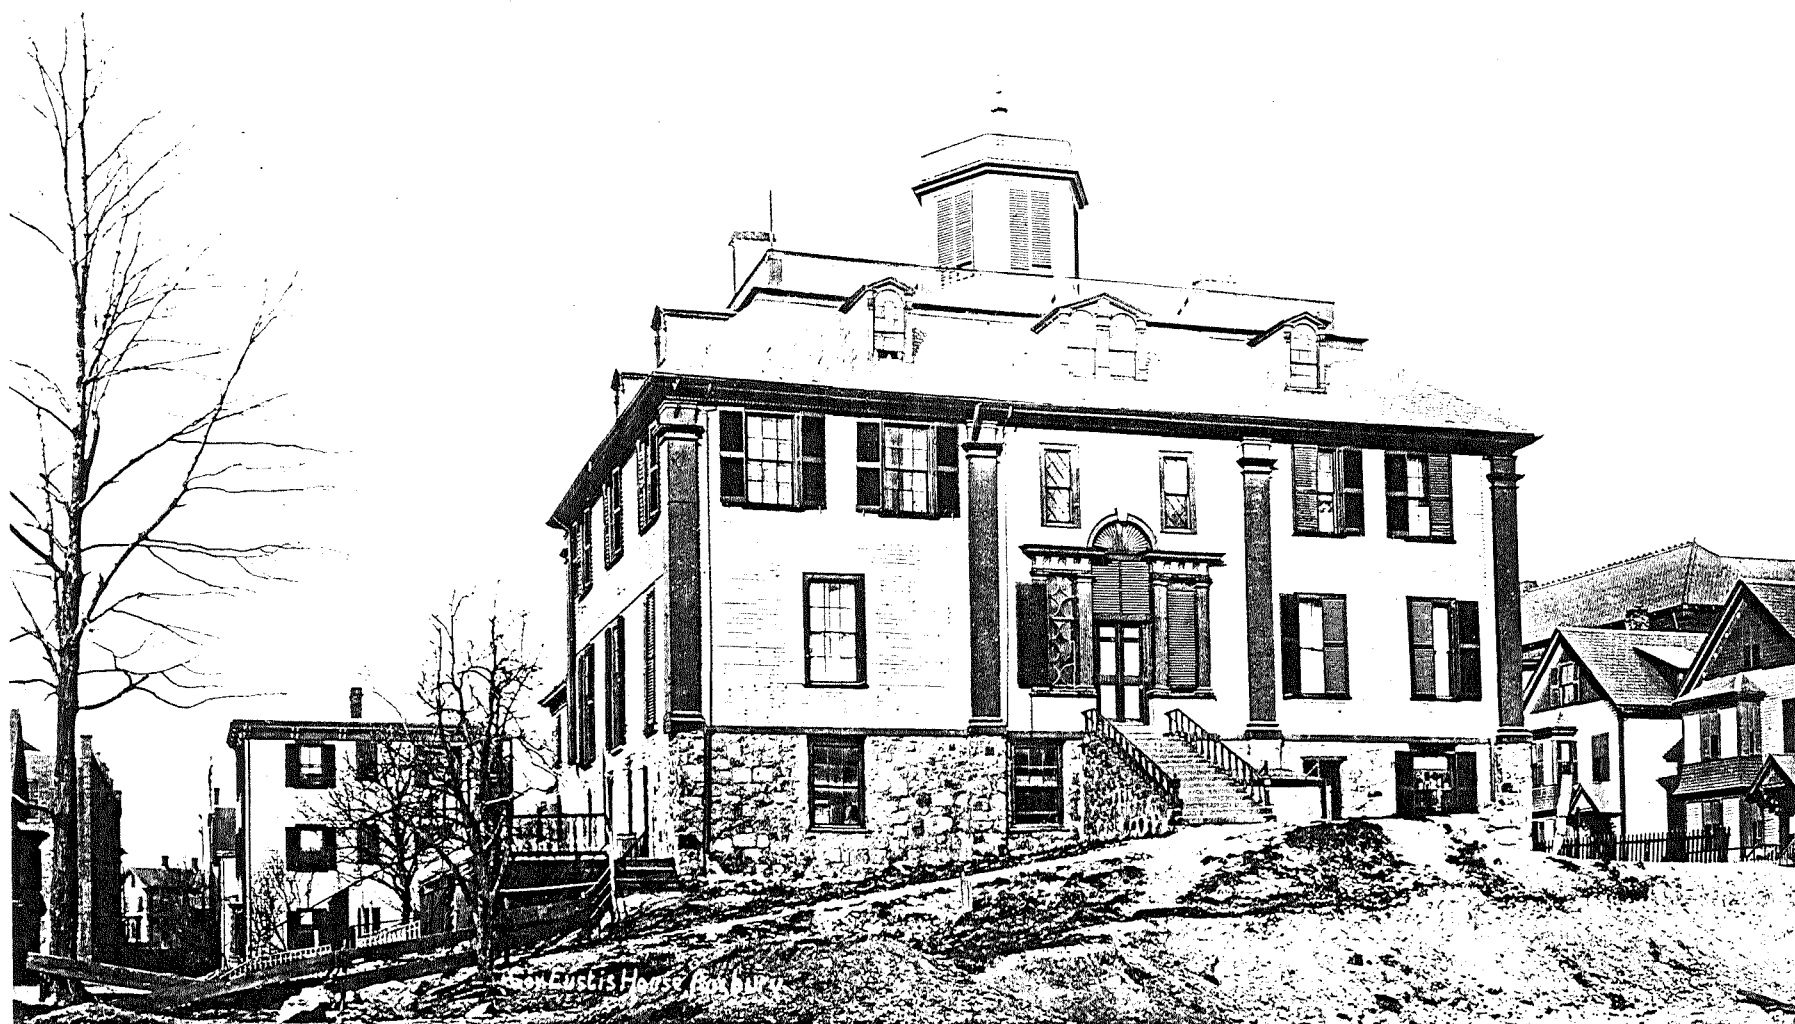
Fig. C-4. "Gov. Eustis House, Roxbury", photo from east, 1890 by W. F. McIntire. Earliest photo of east front before construction of adjoining buildings showing surviving piazza base, double dormer and twin second floor sash added. (SPNEA Neg.)

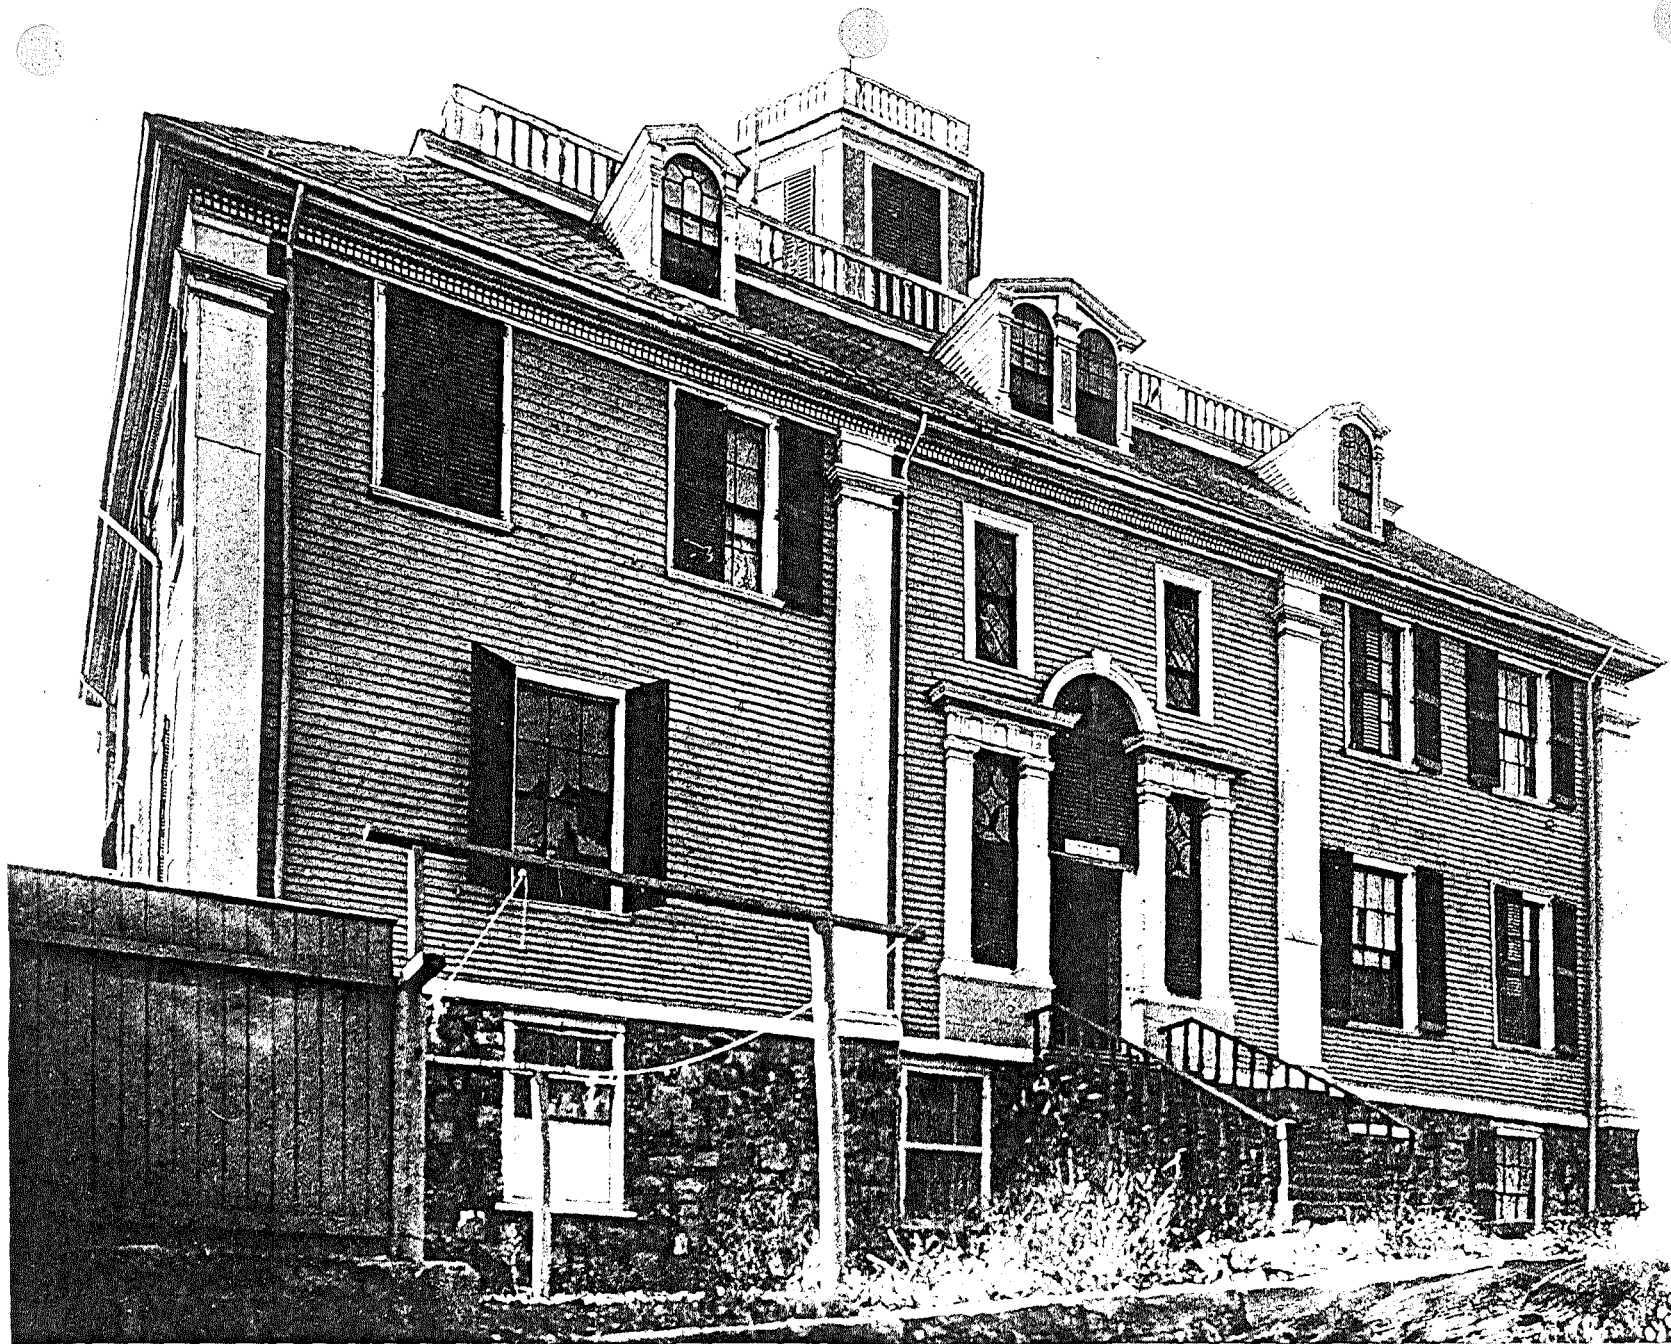
Fig. C-6. "Governor Eustis Mansion, Roxbury, Massachusetts",
photogravure from southeast. Plate LIX from
Colonial Architecture and Furniture, E. E. Soderholtz,
(Boston: Geo. H. Polley & Co., 1895). (SPNEA
Neg. 11234-B)

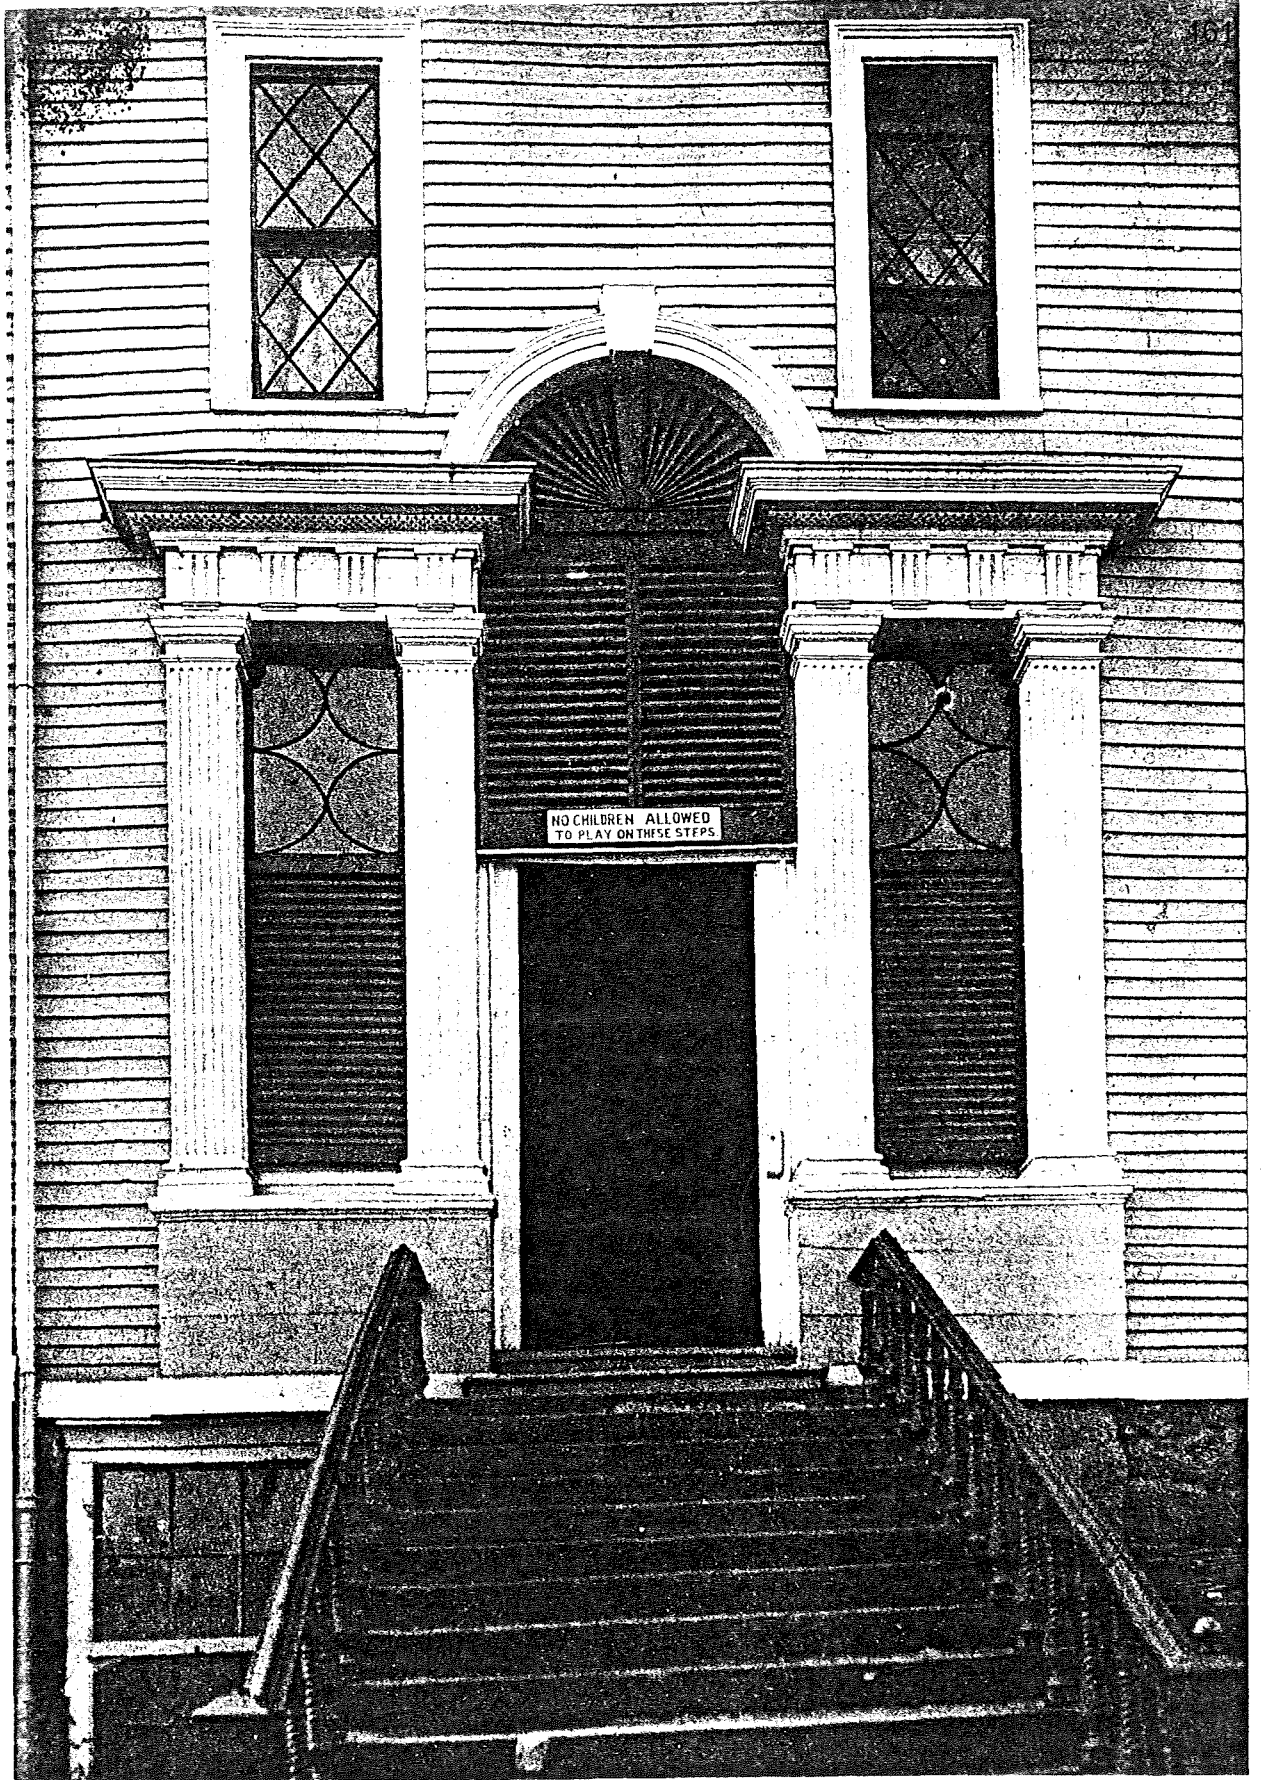
Fig. C-7. East "Entrance Front, Governor Eustis Mansion", Roxbury, Ma. Photogravure showing "Venetian Palladian doorway. Plate LX from Colonial Architecture and Furniture, E. E. Soderholtz, (Boston: Geo. H. Polley & Co., 1895). (SPNEA Neg. 11234-B)

On the exterior, the Doric entablature and pilasters of the east entrance, are an original feature, seen with some Federal alterations in an old photo (Fig. C-7). The west entrance with its rusticated imitation stone pattern, also seen in an old photo, is almost entirely original as is probably the case with some of the first floor window frames with molded sills, and others possibly re-used elsewhere (Fig. C-12). Even the cupola retains some of the original sash, frames, finish wood floor and plaster surfaces.

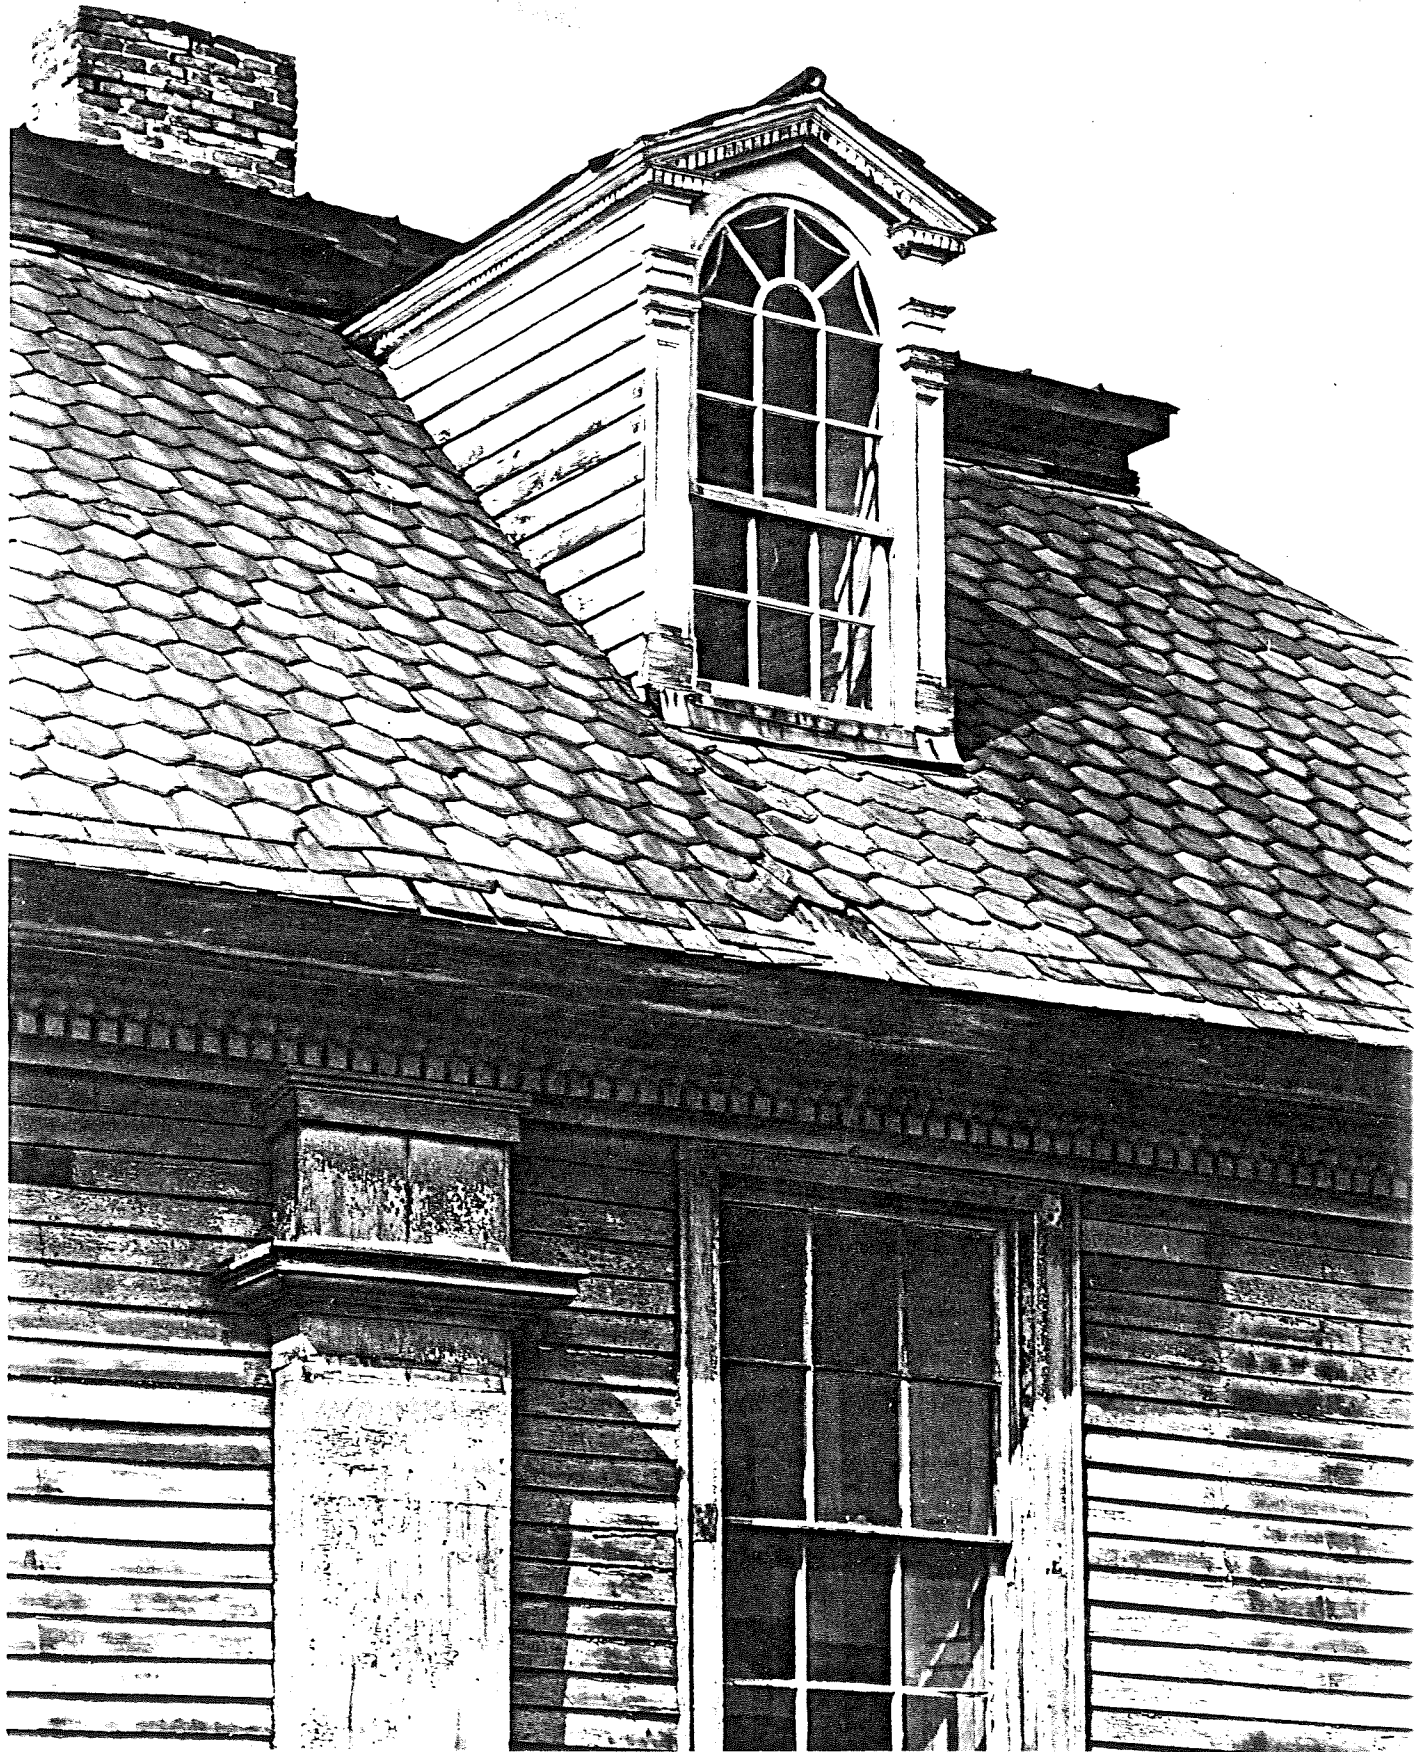
Fig. C-9. Shirley-Eustis House, east dormer, cornice, and pilaster capital detail showing seam at removed neck molding, possible evidence of former entablature. Arthur Haskell photo, 2 September 1939. (SPNEA Neg. 13204 AH)
