HISTORIC STRUCTURE REPORT

SHIRLEY-EUSTIS HOUSE

Roxbury, Massachusetts

1979

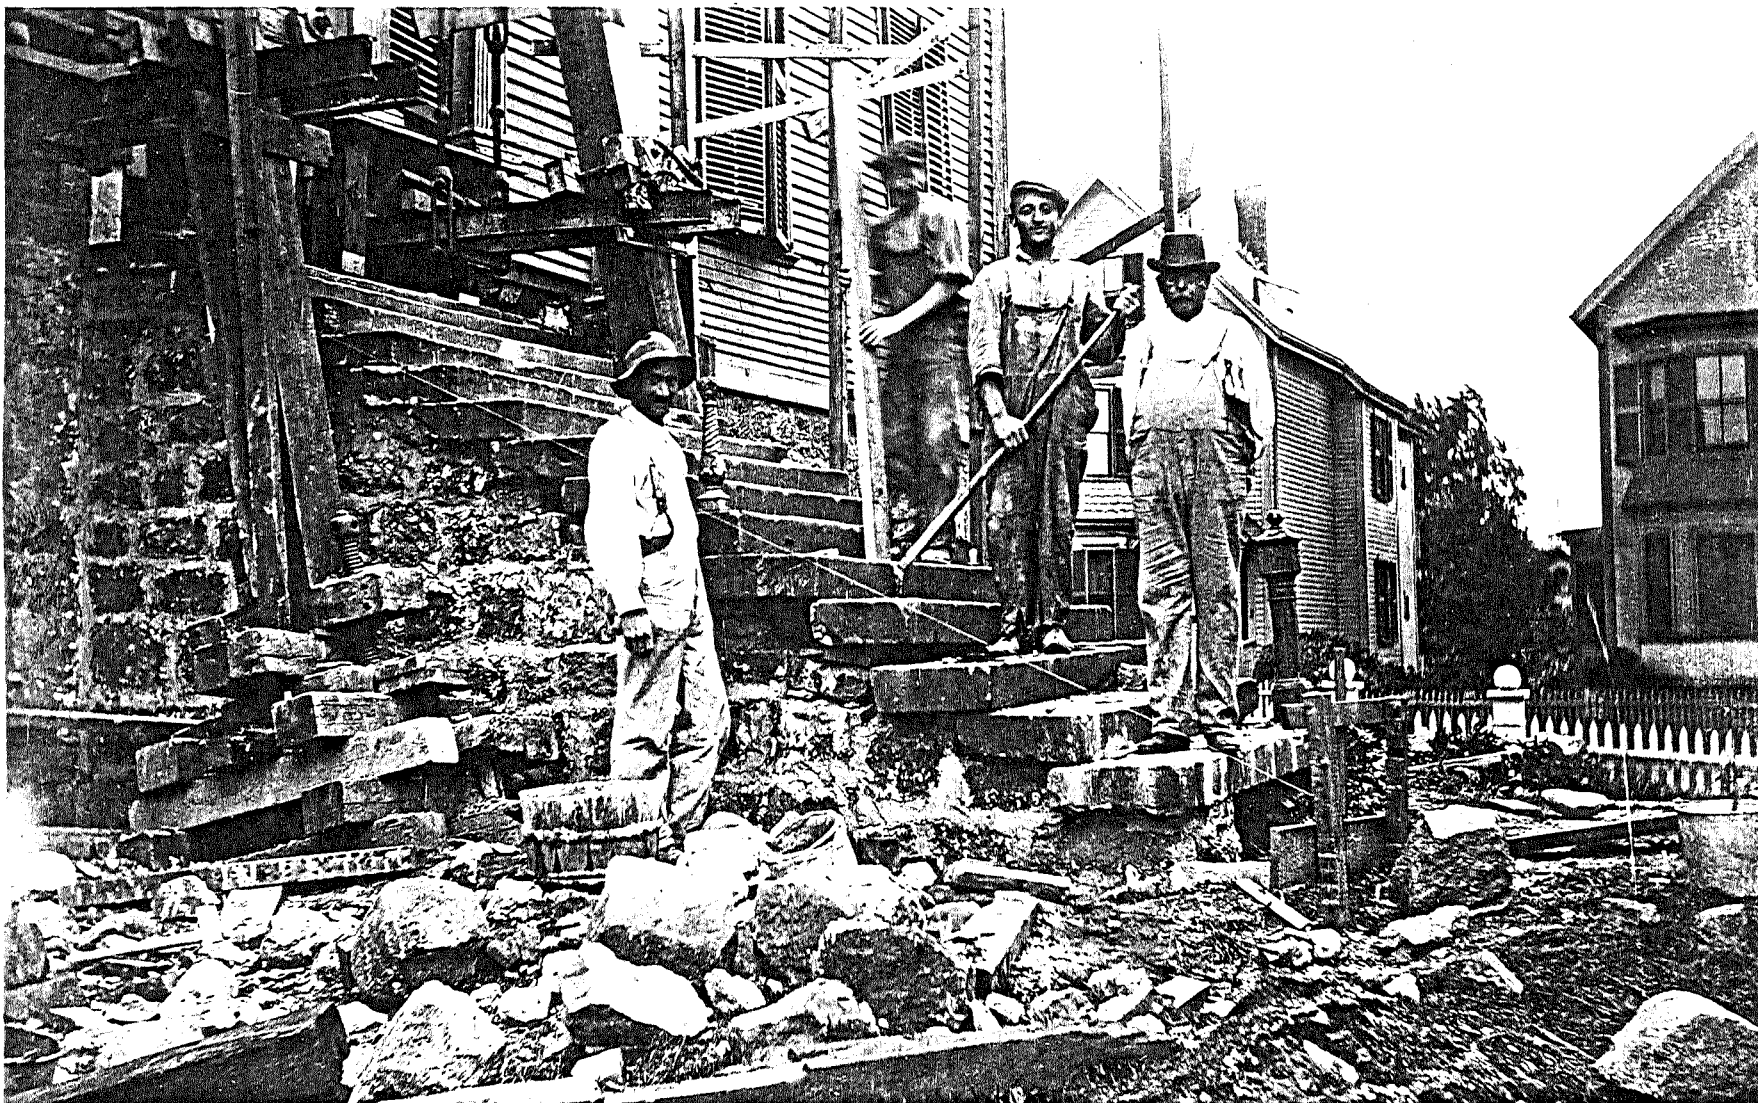
Fig. C-11. Shirley-Eustis House, southeast view of east front steps and workmen, "Mr. Bowen," contractor, during 1915 repairs. Photo by Lillie B. Titus, Shirley-Eustis House Association. (SPNEA Neg. 6636-B)

- Fig. C-11. Shirley-Eustis House, southeast view of east front steps and workmen, "Mr. Bowen," contractor, during 1915 repairs. Photo by Lillie B. Titus, Shirley-Eustis House Association. (SPNEA Neg. 6636-B)

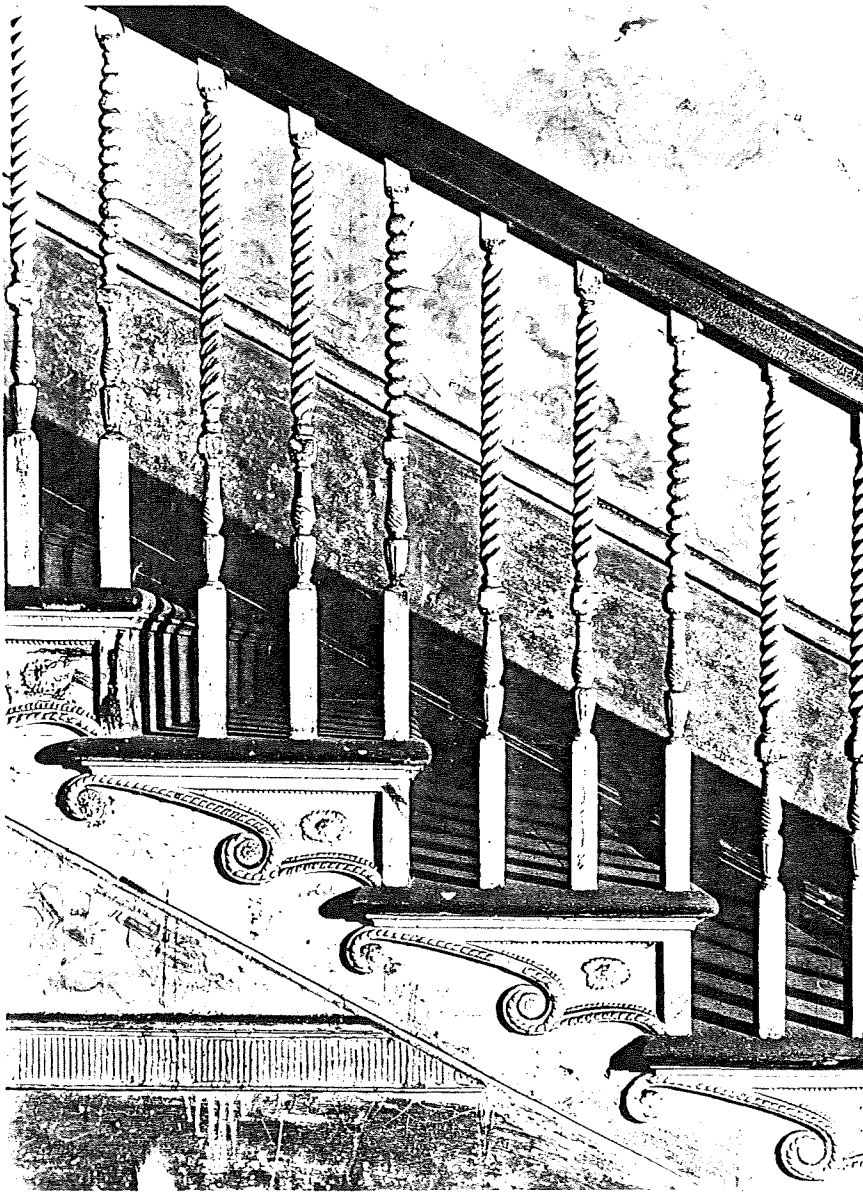
Fig. C-14. Shirley-Eustis House, East Hall, photo, detail of stair showing putty scroll decoration of stringer and twist-turned balusters. Photo by Curtis, 1 August 1939. (SPNEA Neg. 10785-A)

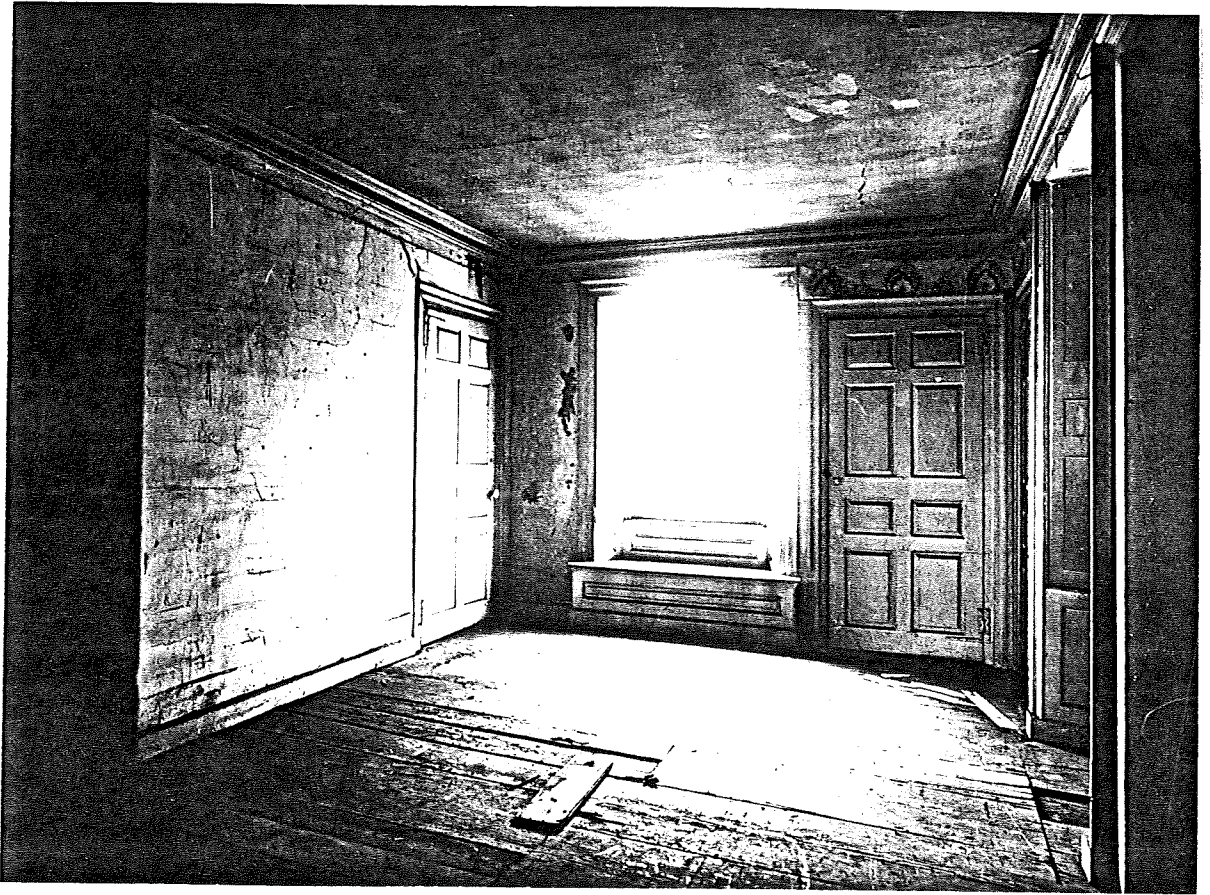
Fig. C-15. Shirley-Eustis House, northwest Library Chamber, west end, before restoration, 1940. Photo by Mixon. (HABS, Mass-275). (SPNEA Neg. 10777-A)

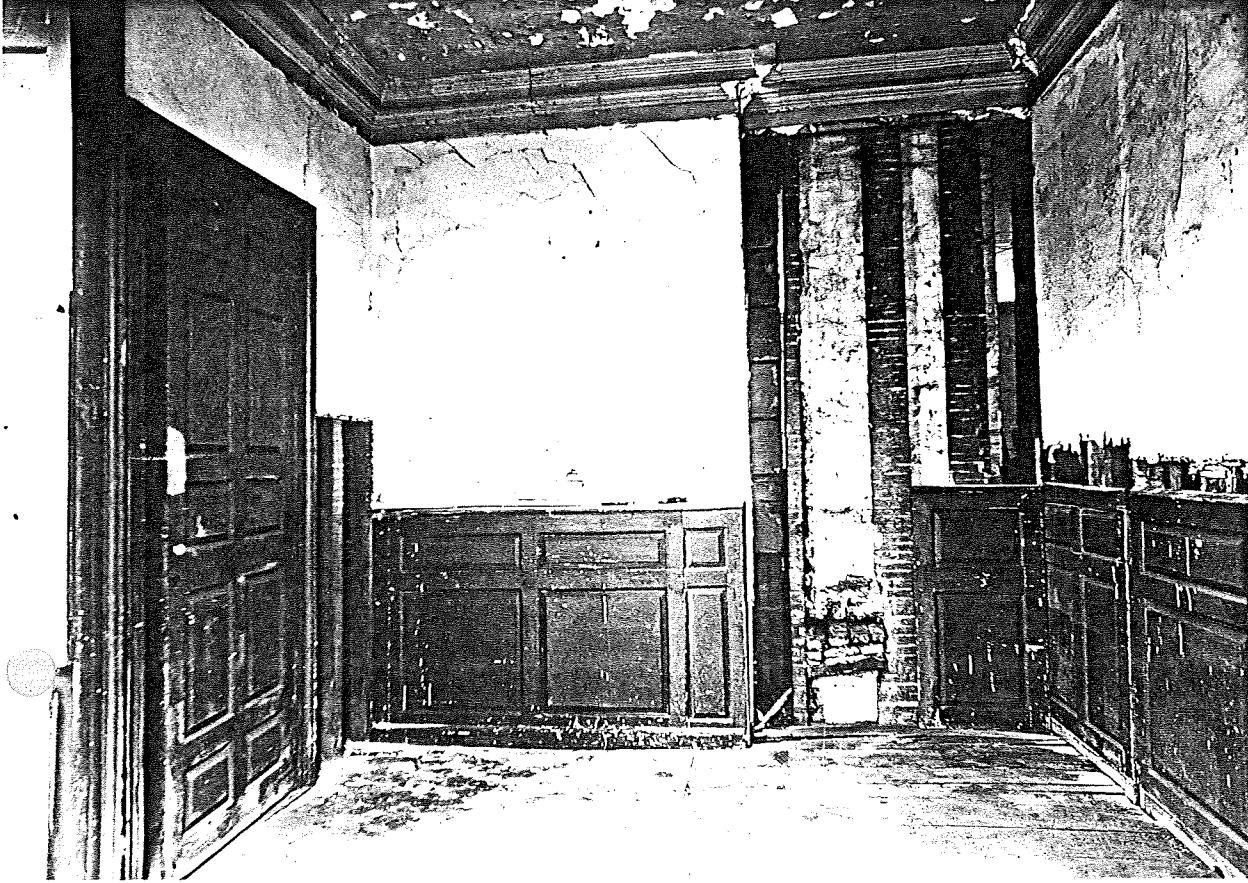
Fig. C-16. Shirley-Eustis House, northwest Library, east end, before restoration, 22 May 1940. Photo by Nixon. (HABS, Mass-275). (SPNEA Neg. 10778-A)
